EFFECTS OF PROCESS CONDITIONS AND MICROSTRUCTURE ON THE FATIGUE AND FRACTURE OF AM IN718

Alexander Caputo^{1*}, Richard W. Neu^{1,2}, Xiayun Zhao³, Chaitanya Vallabh^{3,4}, Haolin Zhang³

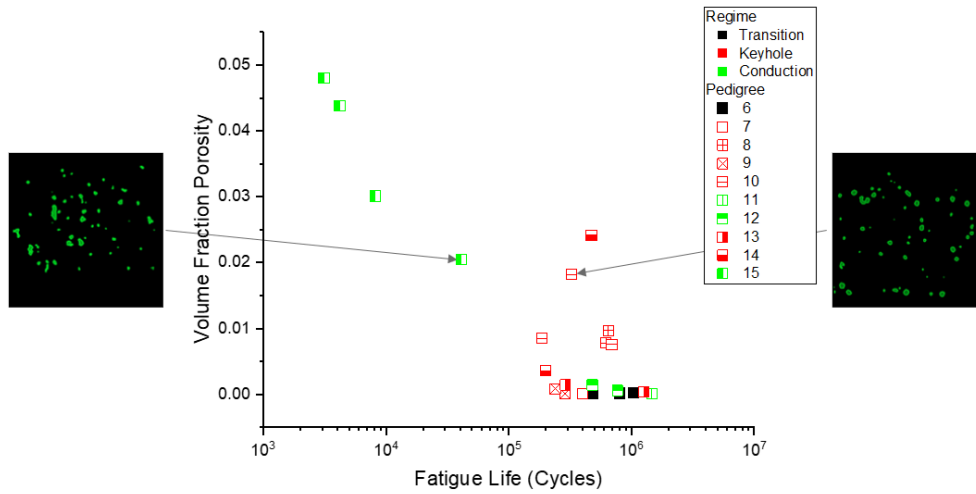
XCT analysis of porosity within the gage regions of the fatigue specimens prior to HCF testing has shown that the number and morphology of pores is directly related to the process conditions. In combinations of process parameters that create a relatively low volumetric energy input, also known as being in the conduction regime, porosity manifests in large irregular pores created by subsequent layers inadequately fusing. These lack of fusion pores are often large (100 – 500 μm) and contain sharp edges. On the other side of the spectrum, in the keyhole regime with high volumetric energy inputs, porosity manifests as mainly round or generally spherical keyhole pores. Pore morphology directly influences the effect any given porosity has on the fatigue properties of AM IN718. Fig. 1 depicts the general trend of increasing fatigue life with decreasing volume fraction of porosity within the gage region. Also in Fig. 1, cross sectional slices of the segmented XCT pore reconstructions of specimens 15E and 10J show that within specimens with the same total amount of porosity, having large irregular lack of fusion pores causes the fatigue life to be an order of magnitude lower than a specimen containing spherical keyhole type pores. The general trend of increasing life with decreasing volume fraction of porosity is not observed in specimens with minimal porosity. It is in these specimens where pores are infrequent that fatigue crack formation has been observed to originate simply from crystallographic grains with orientations and sizes that are particularly vulnerable to the applied cyclic load. The highest fatigue life specimens from samples 11 and 13 show this type of

Fig.1 – Relationship between fatigue life and volume fraction with XCT cross sectional slices of specimen 15E containing lack-of-fusion porosity (left) and 10J containing keyhole porosity (right).

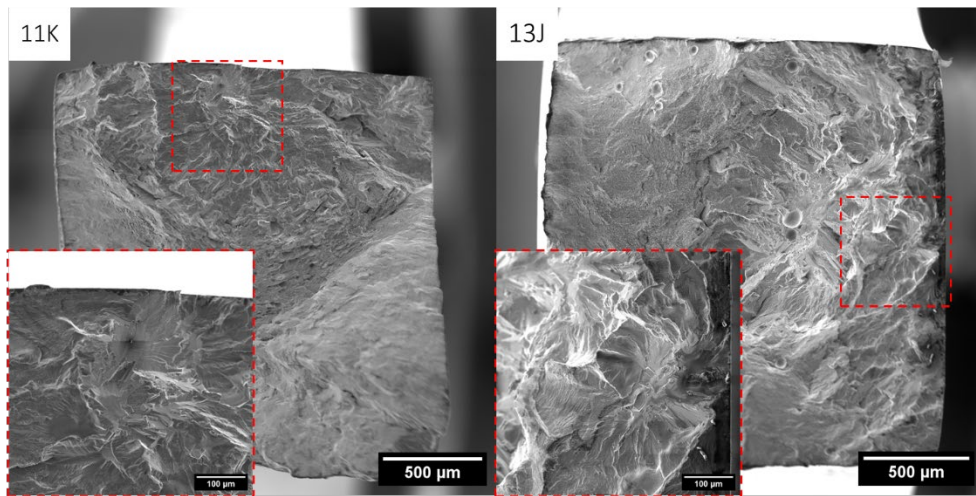
initiation that closely resembles fatigue crack formation in wrought IN718 specimens tested under the same conditions. The fracture surfaces of specimens 11K and 13J are shown in Fig. 2. In the fracture surface of 11K, the faceted nature of the surface around the region of initiation is evidence that it was a crystallographic microstructural feature that caused failure. In contrast, in 13J the faceted surface in direct proximity to a near-surface pore shows that both microstructure and the porosity led to fatigue failure.

Fig.2 – SE-SEM fractographic images of two specimens having minimal porosity, 1 11K and 13J, with higher magnification overlays of the site of fatigue crack initiation.
