## Recent Natural Gas Pipeline Accidents Involving Hydrogen Induced Cracking

M. K. Budinski<sup>1\*</sup>, F. Zakar<sup>1</sup>

<sup>1</sup>National Transportation Safety Board, Washington, DC, USA,  
\* Presenting Author email: [michael.budinski@ntsb.gov](mailto:michael.budinski@ntsb.gov)

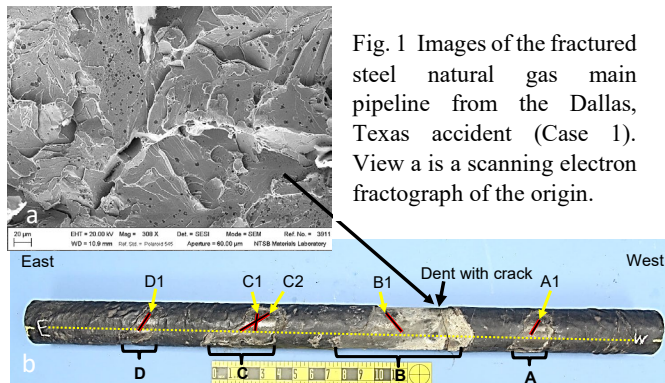
Case 1: On February 23, 2018, a natural gas–fueled explosion occurred at a private home in Dallas, Texas. [1,2] The residence sustained major structural damage. Four family members were injured, and one was killed in the explosion. Following the explosion, National Transportation Safety Board (NTSB) investigators located a through-wall crack in the 71-year-old 2-inch diameter steel natural gas main that served the residence. Natural gas leaking from the cracked gas main in the alley behind the home migrated through the soil and into the house where it was ignited by an unknown source. Soil absorbed and depleted the natural gas odorant, eliminating the opportunity for occupants to detect it by smell. Installed in 1946, the gas main had a maximum allowable operating pressure (MAOP) of 55 psig. The coated steel main was cathodically protected by sacrificial anodes and the natural gas was odorized. The natural gas leak rate was estimated based on NTSB's laboratory testing to be between 8 and 14 CFM at the operational pressure range of the system of 17 to 45 psig. Example images are in Figure 1.

Fig. 1 Images of the fractured steel natural gas main pipeline from the Dallas, Texas accident (Case 1). View a is a scanning electron micrograph of the origin.

Case 1: The natural gas main was damaged by mechanical excavation equipment, likely when a sanitary sewer lateral was replaced in 1995. A circumferential crack in the main propagated through the pipe wall prior to the incident, allowing natural gas to leak into the surrounding environment for an extended period. Based on the observations, the circumferential crack initiated at the bottom of the dent forming two thumbnail cracks which arrested. At a later point, the balance of the circumferential crack propagated from the thumbnail cracks, driven by a hydrogen-induced cracking mechanism. The crack most likely formed before observed calcareous deposits developed. However, given the above observations, it was not possible to further define the exact timeline of the crack formation process.

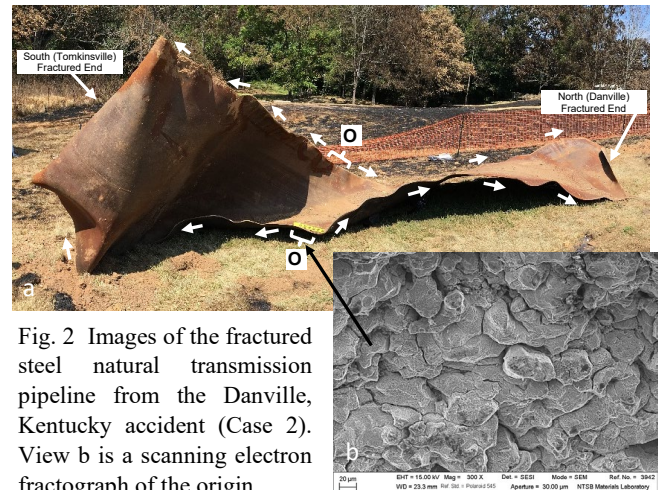
Case 2: On August 1, 2019 a 30-inch-diameter API 5L-X52 steel natural gas transmission pipeline ruptured near Danville, Kentucky. [2,3] As a result of the rupture, 1 person was fatally injured, 6 people were hospitalized, and over 75 residents were evacuated from the Indian Camp Subdivision, a residential community. The rupture released about 101.5 million feet<sup>3</sup> of natural gas and ejected a 33.2-foot-long section of pipeline that landed about 481 feet southwest of the rupture site. The releasing gas ignited and burned. Five residences in the subdivision were destroyed by fires, and an additional 14 were damaged. A nearby railroad track sustained fire damage. At the time of the rupture, the pipeline was operating at 925 psig. The pipeline had a MAOP of 936 psig. The ruptured pipe segment, which was installed in 1958, was manufactured by A.O. Smith Corporation. The pipe segment in the area of the rupture was coated with coal tar enamel and was under impressed-current cathodic protection. Example images are in Figure 2.

Fig. 2 Images of the fractured steel natural transmission pipeline from the Danville, Kentucky accident (Case 2). View b is a scanning electron micrograph of the origin.

Case 2: The combination of a pre-existing hard spot (a manufacturing defect) in the pipe steel, degraded coating, and ineffective cathodic protection applied following a 2014 gas flow reversal project, resulted in hydrogen-induced cracking at the outer surface of Line 15 and the subsequent failure of the pipeline. Contributing to the accident was the 2014 gas flow reversal project that increased external corrosion and hydrogen evolution.
