INVESTIGATION AND REMEDIATION OF A COMPLEX FAILURE OF A HIGH STRENGTH STEEL FAN MIDSHAFT FROM A GENX ENGINE

Erik M. Mueller^{1*}

¹*National Transportation Safety Board, Washington, DC, USA*

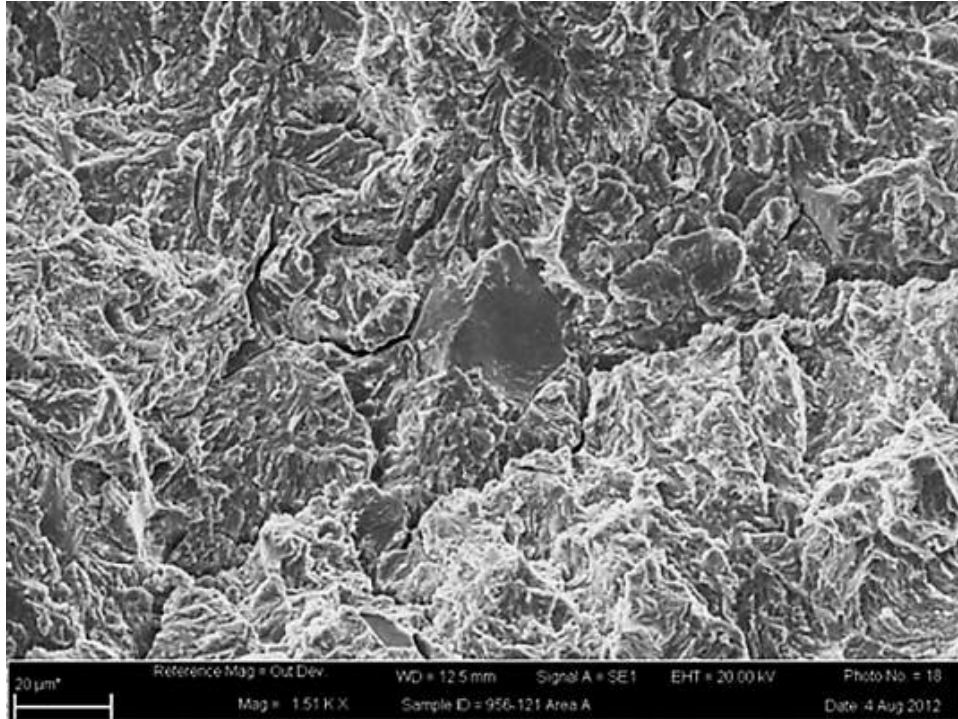
The parties to the investigation performed an extensive fractographic inspection of the fractured fan midshaft as well as a multitude of metallurgical and fundamental scientific tests. The fracture surface exhibited primarily transgranular cleavage features, with some intergranular facets, as typified in Figure 1. These features were consistent with environmentally assisted cracking of the fan midshaft material, an ultra-high strength steel. These fracture features were compared with stress corrosion bending specimens, which exhibited comparable features once fractured. These features were also consistent with those in hydrogen-charged tensile specimen fracture surfaces and were inconsistent with those of developmental fatigue specimens. The remainder of the fracture features were dimpled rupture, consistent with the final overstress fracture of the shaft.

Fig.1 – Secondary electron micrograph of a typical area of the fracture surface features in areas consistent with environmentally assisted crack propagation.
