## **NTSB Accident Investigations Involving Fatigue Fractures Initiating from Subsurface Defects**

Matthew Fox<sup>1\*</sup>, Erik Mueller<sup>1</sup>, Donald Kramer<sup>1</sup>, and Xiaohu Liu<sup>2</sup>

<sup>1</sup> National Transportation Safety Board, Washington, DC, USA

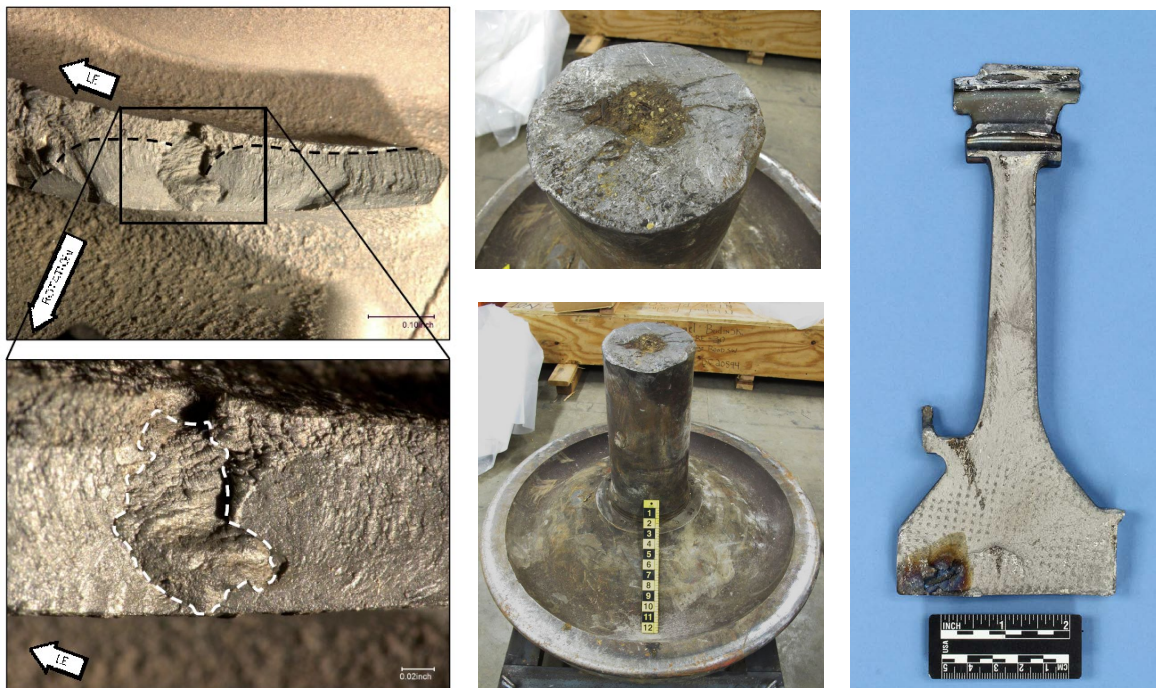
(1) A Piper PA-46-350P airplane experienced a partial loss of engine power during climb due to failure of the right turbocharger. The pilot elected to shut down the engine during the landing approach and crashed short of the runway. A subsequent examination of the turbocharger wheel showed one of the blades fractured at the root due to fatigue that initiated from an inclusion shown in figure 1. The defect was characterized using scanning electron microscopy (SEM) and energy dispersive x-ray spectroscopy (EDS) on the fracture surface and in a metallurgical section through the origin area. Additional information was obtained using a focused ion beam to mill into the inclusion on the metallographic section.

(2) A train car hauling grain derailed due to a fractured axle, obstructing an adjacent track. A train hauling crude oil on the adjacent track collided with the derailed train car, resulting in the release and ignition of crude oil. The axle on the derailed grain car fractured due to fatigue that initiated from an internal casting void shown in figure 1. In addition to characterizing the fracture mechanism, the initiating void was analyzed using a coordinate measurement device to obtain a three-dimensional representation of the void. This data was then incorporated into a finite element model to study the stresses associated with the specific void geometry under axle loading conditions.

(3) American Airlines flight 383 had started its takeoff ground roll at Chicago O'Hare International Airport when an uncontained engine failure and subsequent fire occurred in the right engine from a high pressure turbine (HPT) stage 2 disk fatigue fracture as shown in figure 1. The fatigue crack initiated at a subsurface

anomaly known as a discrete dirty white spot. Characterization of the failure included striation counting, metallographic examinations, microhardness measurements, and compositional analysis using EDS and wavelength dispersive x-ray spectroscopy (WDS).

Figure 1. Turbocharger turbine wheel fractured blade (left images), rail car axle fracture with central void (middle images), and HPT stage 2 disk fracture surface (right image).
