INTEGRATION OF ELASTIC WAVE VELOCITY INTO BIM OF DAM FACILITY

Tomoki Shiotani^{1*}, Hisafumi Asaue¹, Nobuhiro Okude¹, Norihiko Ogura¹, and Fumitake Kunisue²

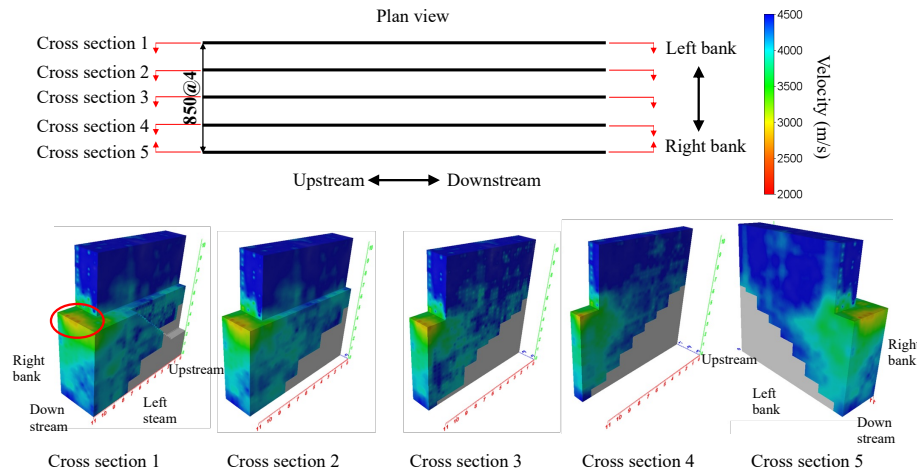
Tomogram is demonstrated as in Fig. 1. In Fig. 1, 2D sectional tomograms from section 1-5 are depicted. A good agreement of the location of serious surface cracks and areas showing small velocity as less than 3000 m/s is obvious indicated by a red circle in section 1 of Fig. 1. The surface crack condition of left bank side and 3D tomogram are shown in Fig. 2, where the binarized image based on the velocity of 3500 m/s is demonstrated in the middle of Fig. 2. Red areas show the velocity less than 3500m/s while the blue shows it larger than 3500 m/s. It is obvious that serious crack locations are well identified with red areas. It is noted that the area where surface cracks are observed on the left bank side (see the right photo of Fig. 2), there was no area of red, showing the velocity less than 3500 m/s, suggesting that the crack on this left bank surface will not be expanded into a deeper area of the wall. This estimation was subsequently verified by borehole cameras' observation after excavating holes up to 50 cm depth. The deepest cracks could be observed up to 13 cm depth. This result are well accorded to the estimation by the tomography.

Fig.1 – Distributions of elastic wave velocity (Tomogram).

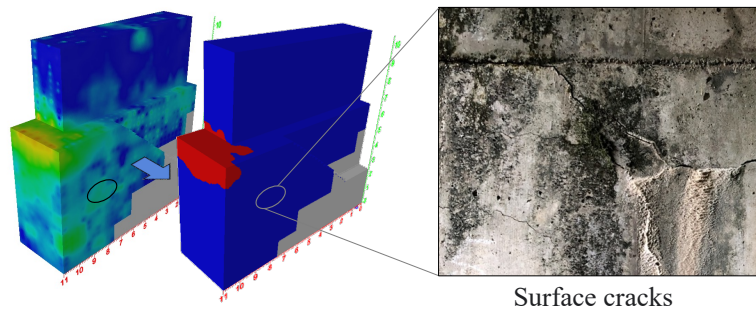
Fig. 2 - Comparison between tomogram and surface cracks of left bank side.
