INTEGRATION OF ELASTIC WAVE VELOCITY INTO BIM OF DAM FACILITY

Tomoki Shiotani^{1*}, Hisafumi Asaue¹, Nobuhiro Okude¹, Norihiko Ogura¹, and Fumitake Kunisue²

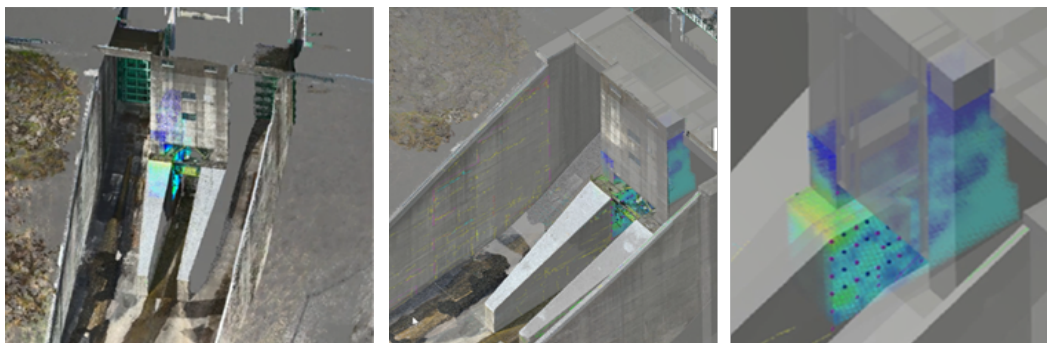
The spillway is reproduced by 3D point-clouds using still and video images, tomograms namely internal velocity distributions, 2D surface observations and design drawing. The integrated model and details of superposition of surface and internal information are demonstrated in Fig. 3. By using Fig. 3, the structure of interest can be visualized in 360 degrees in all directions. Damage specifications such as crack width, length as well as density can be visually quantified and overall internal damage can be confirmed by the tomograms. Classification of damages and interpretation of structural performance will be automatically implemented with using AI near future. When the shown inspections are periodically carried out and visualized with the proposed integration procedure, rational maintenance program through the life cycle of the structures will be reasonably proposed.

Fig. 3 - Resulted digital twin incorporated point-clouds, surface condition and internal elastic wave velocities.
