FLOWFORMING TO IMPROVE THE FATIGUE LIFE OF IMPLANTS?

Mohamed Akram Mechter¹, Mina Gadour¹, Léa Romain¹, Myriam Brochu¹

Fatigue failure of 316L femoral implants is reported in the literature with a crack initiation mostly located at fixation holes. This research project aims at improving the fatigue resistance of the material surrounding the holes using flow forming processes. A comparative analysis of the microstructure, the fatigue life and the fractured surfaces of 316L stainless steel bars drilled and tapped with two different processes is presented.

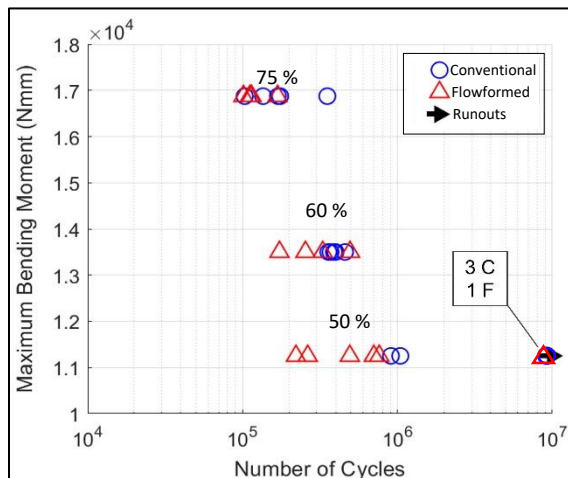
Fig.2 – Fatigue tests results

The results of the fatigue tests are provided in Fig.2. No significant differences in fatigue life for tests performed bending moment is equal to 75% and 60% of the yield bending moment. Nevertheless, when the maximum bending moment applied was limited to 50% of the yield bending moment, the specimens containing holes manufactured by the cutting endure more cycles.
